May 2015

Case Study

Capacity Loss in Gas Turbines

EMW® (H)EPA Filtration vs. Compressor Fouling

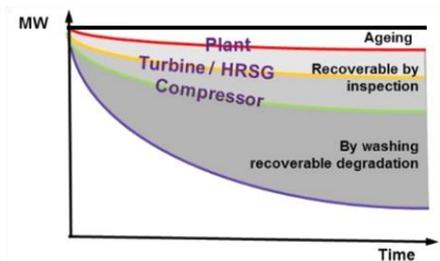
Compressor fouling causes roughly 70 – 85% of power capacity loss in gas turbines. This problem can be avoided by more efficient filtration providing a cleaner inlet air stream. EMW® can often upgrade users' filtration systems without need for replacement or modification of the filter house.

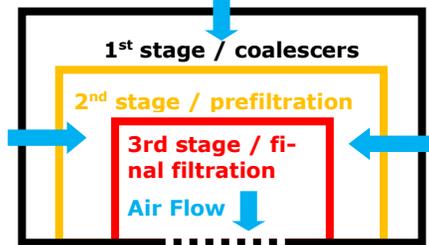
Figure 1.1

Entering the filter house from three sides, the inlet air stream passes through a 3-stage filtration system incorporating 540 filters in each stage. In the owner's existing configuration, the first filtration stage was equipped with Class G3 coalescers, the second stage with Class G4 Class prefilters and the third stage with Class F7 fine filters.

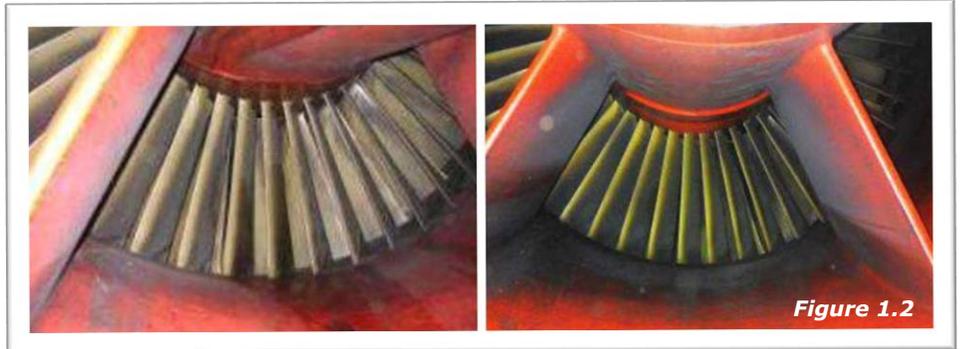
Figure 1.2 shows heavy fouling build-up in the compressor. The fouling was caused by insufficient inlet air filtration permitting particulate passage into the gas turbine.

Figure 1.2 shows the severe fouling build-up encountered with the existing filter configuration. The filter system did not provide the required efficiency, allowing fine particles to enter the gas turbines in large quantities.

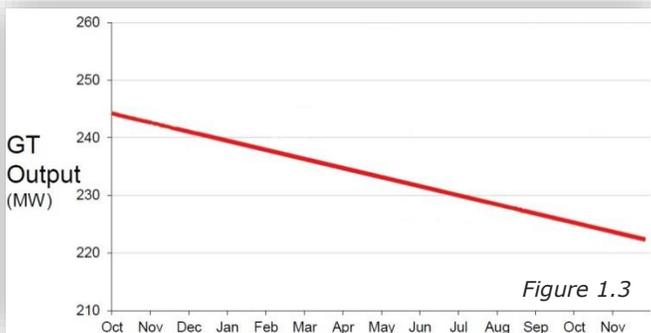
Figure 1.3

Power Output and Heat Rate vs. Operating Time

The above graphs show power output capacity and heat rate as functions of operating time (without taking compressor washing into account). Including the remediative effects of the washing, power output decreased by an average of 3 % and heat rate increased by 1.3 % over the 12 month period shown. Factoring in the turbines' 6000 operating hours per year, the resulting power loss amounted to 22,320 MW. Adding in the effects of increased fuel consumption, the problem was costing the operator a grand total of € 925,000*(\$1 million) per year. All due to: compressor fouling.

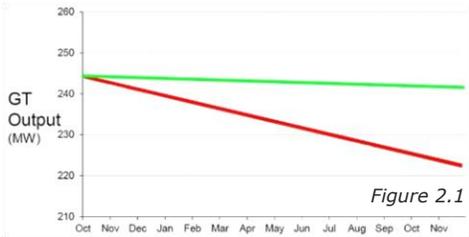
Figure 2.1

Capacity drop with old filter system 3% and, after EMW® upgrade 0.8%

The EMW® upgrade significantly boosted power output, reducing the average capacity loss over 6000 operating hours to only 0.8% per year as opposed to 3.0% with the old configuration. As noted above, a certain amount of capacity drop is related to ageing as opposed to fouling. The other (and larger) part of capacity drop, i.e. that caused by compressor fouling, was virtually eliminated on a lasting basis by the upgrade. The upgrade also reduced the average heat rate increase over a 12 month period to only 0.6% per year as opposed to 1.3% with the old configuration.

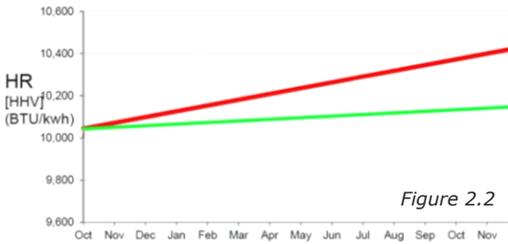
Figure 2.2

Increase in heat rate with old filter system 1.3% and, after EMW® upgrade 0.6%

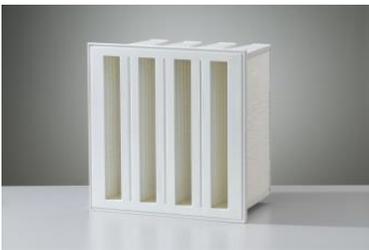
EMW® MINIPLEAT COMPACT CASSETTES

The upgrade included a changeover from Class F7 fine filters to **EMW® (H)EPA** Class E12 fine filters. The EMW® filters provide convincing benefits by removing virtually 100% of even the finest-sized particles with only moderately increased pressure drop over the filter lifespan.

The filtration performance in the inlet air system was improved by upgrading the filter class from F7 to (H)EPA E12, i.e. a jump upwards of 5 filter classes. The EMW® filter version used was [MPK 4 12-31 GT](#).

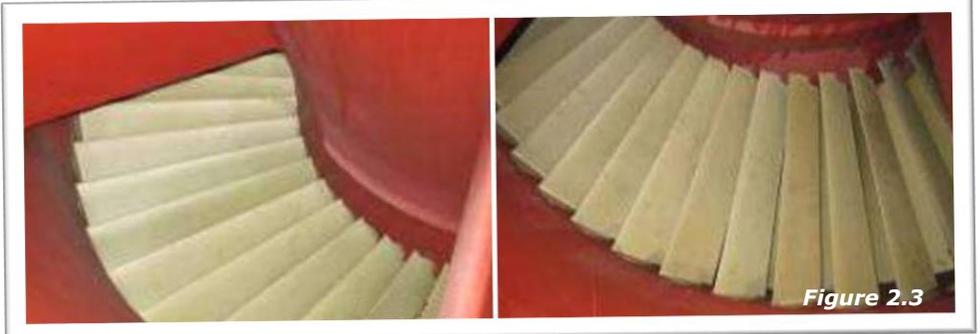
Figure 2.3

Following the EMW® upgrade, compressor fouling is almost nonexistent. The gas turbines have been in operation since 2012 without need for on/offline washing to date.

As shown by the photos at right (Figure 2.3), the filter upgrade virtually eliminated fouling. Power capacity of the gas turbines also got quite a boost. The upgrade restored power output of the gas turbines, reducing the average capacity loss over a 12 month period to only 0.8 % per year as opposed to 3.0 % with the old configuration.
